Alvis Model: 1961 TD21 Series 1

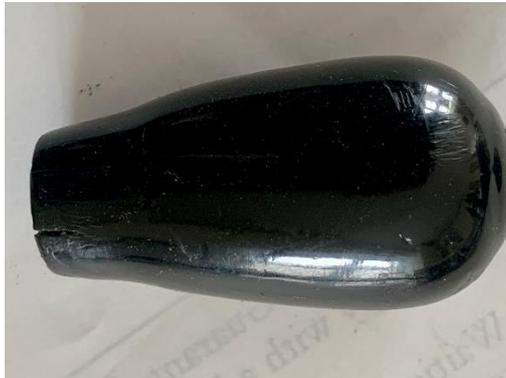
1.

Knob showing crack at base

I promised to report back on how long the repair lasted; and the answer is, it didn't!
A couple of days later whilst removing the gearbox tunnel carpet the knob came off. The problem was that oily vapour had impregnated the plastic of the knob and prevented a sound bond.

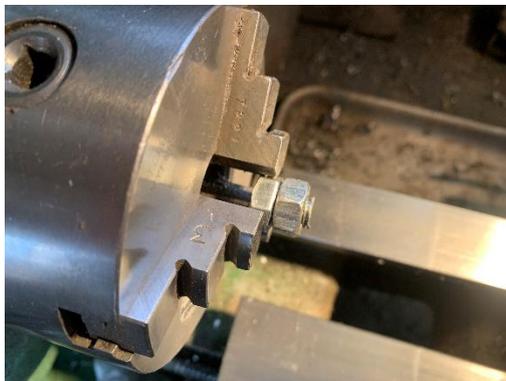
2.

Nut mounted in Chuck

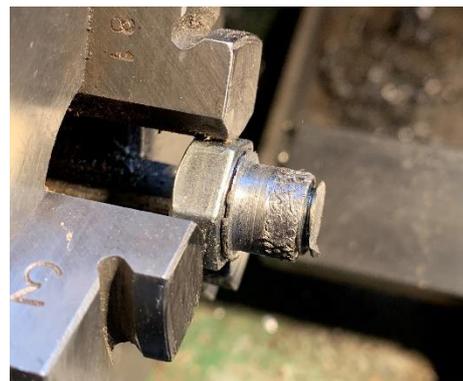
3.

Nut turned down and knurled but not tidied up.

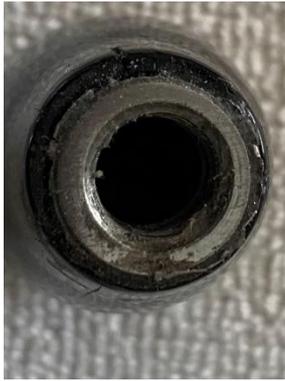
4.

Insert glued in place

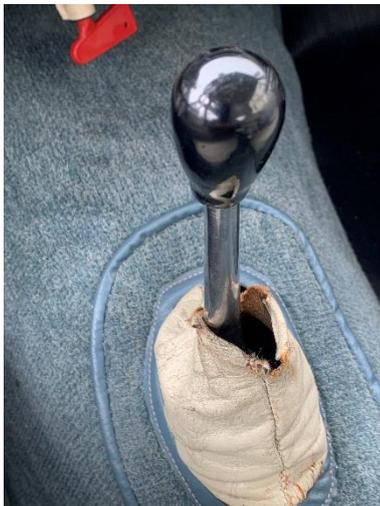
5.

completed knob back in

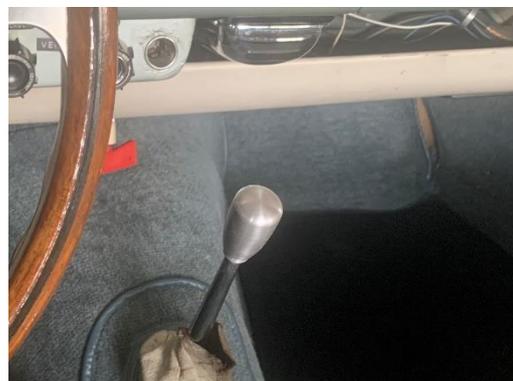
aluminium gear lever knob made for
TD21

I judged that by the time I had bored out the contaminated plastic the knob would be too weak. I therefore tapped a 3/8" Whitworth thread down the centre of a bar of aluminium and made myself a new knob which goes well with the Nardi steering wheel.
