The First Speed 20 the SA 19.92 h.p.

Nick Simpson

AOC Technical Officer

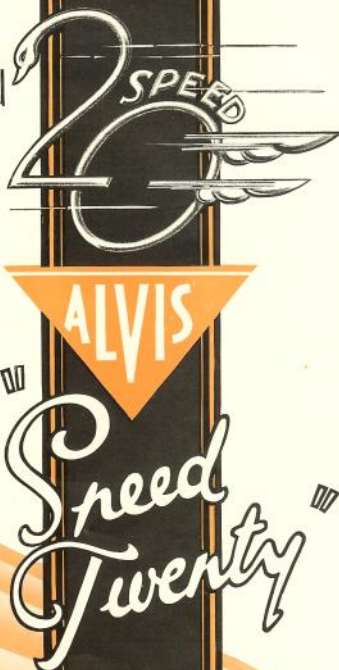
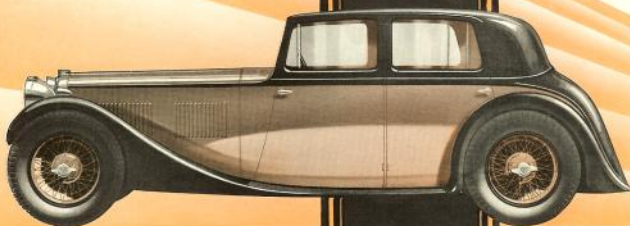
Period advert for the standard Charlesworth SA Speed Twenty saloon. This appeared in September 1932 and the car is a heavily re-touched artists impression from a photograph; it has early 1932 doors with angular front shut lines and the 1933 rear end shape! Just to complicate matters, the image is reversed; the spare wheel is normally carried on the left side! This is probably chassis 9406, KV707, the first Charlesworth saloon with the early 'flat' radiator, a Works car. Saloon production did not begin until July 1932 by which time the factory had organized coachwork supplies to take advantage of the market for a "sports saloon". This body style had been around for some years but had only been a small niche market until post Depression, saloon coachwork could be produced for less of a premium than in the past.

1932 Charlesworth saloons had a very obvious angular front bottom to the front doors with boot access with two lids. 1933 Model Year rounded out the

leading edge of the door bottoms and there was a more curvy, less angular rear end shape with single boot lid and the front wings lost their 'skirts', later reinstated on the SC model for 1935!

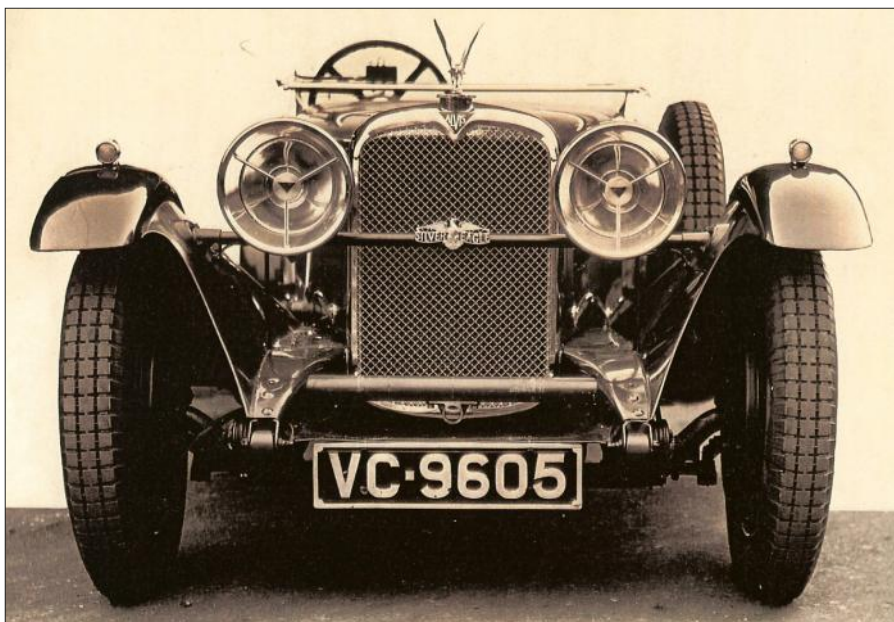
The prototype SA 20. This is the first chassis, 9184, VC9605 built October 1931 with an experimental Cross & Ellis sports body prior to public launch, at which time the model was still known as the 'Silver Eagle Sports' and even became the 'Silver Dart' for a short while until the name 'Speed Twenty' was settled on. This car was clearly intended as a serious sporting machine! Note the small mechanical wiper motor. The double-dipping headlamps were not specified for production. This car was later re-bodied by the Works with a Charlesworth FHC and re-registered with KV1577 before being sold.

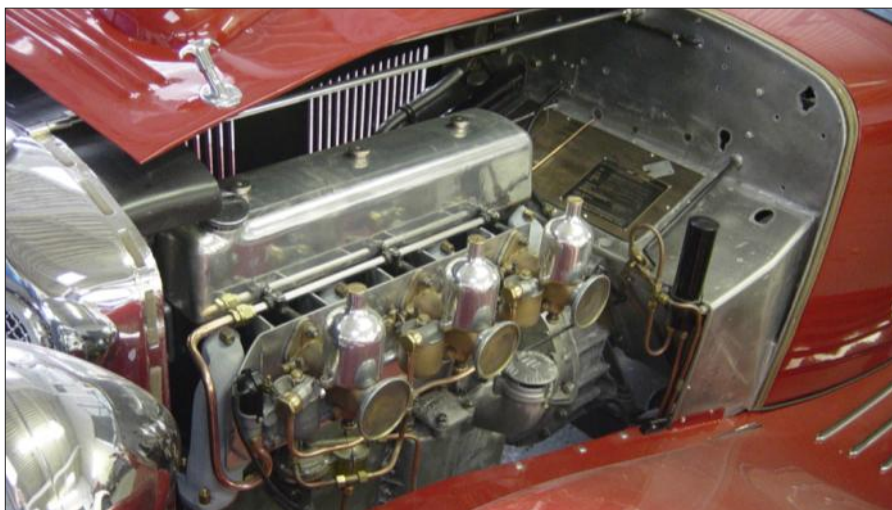
A general under-bonnet view of the author's SA 20. The vertical black tube on the right of the bulkhead is the fuel reservoir to keep a head of fuel in the float chambers. When new, the Speed Twenty was intended to promote quality with its well-finished engine parts and plated pipes under-bonnet. Following the successes of the Twelve-Fifty and Silver Eagle it had a lot to live up to. This engine is fitted with a later Silver Crest valve cover.

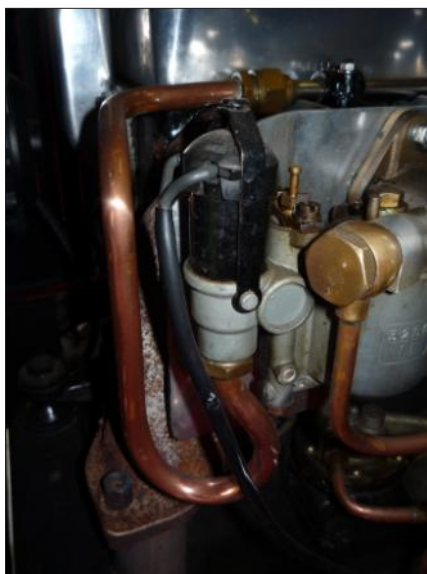
A close-up of the S.U. electric choke installation. As a non-original feature, it installed as discreetly as possible. With the adjustable jetting and air inlet, a fast idle on choke is useful. It does not require the mixture diffusion tube in the balance pipe as specified in the mid-period choke system.

I found the best solution was fitting the SU electric choke from a Three Litre – this works very well, is pretty discreet and gives automatic fast idle. I added jet turn-screw adjusters to the three carburetors from the later cars for easy mixture adjustment and this avoids readjusting the original choke linkage every time..... I just hated messing with the original system; it cost a fortune in re-bushing links and never worked effectively for long. The displaced parts are packed in a box in the garage for the next keeper....

The balance pipe across the three inlet tracts needs watching. Be especially suspicious if it is smartly chrome plated; the platers polishing process will often reduce the diameter or the tube so it will not seal with the normal gaskets on its three saddles. This can lead to all sorts of poor running and non-starting troubles. If the tube diameter is suspected, a nicer job may

be made with a length of stainless tube; it polishes nicely and is much stronger. Remember, if you use the choke system from a later Speed model, the balance tube must be fitted with a mixture diffuser tube inside for even mixture distribution during the choke/starting phase.

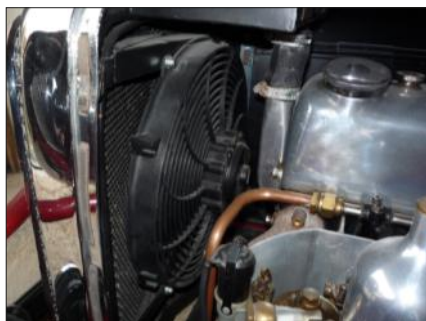
14 inch electric cooling fan. This is the size of equipment required to cool these engines under continental summer conditions if the car is to be enjoyed without unwanted stops. The fan must of a type with the blades enclosed in a housing and fitted as close to the core as possible. Any air spaces around the fan frame will allow air to be drawn in from the sides of the fan frame.

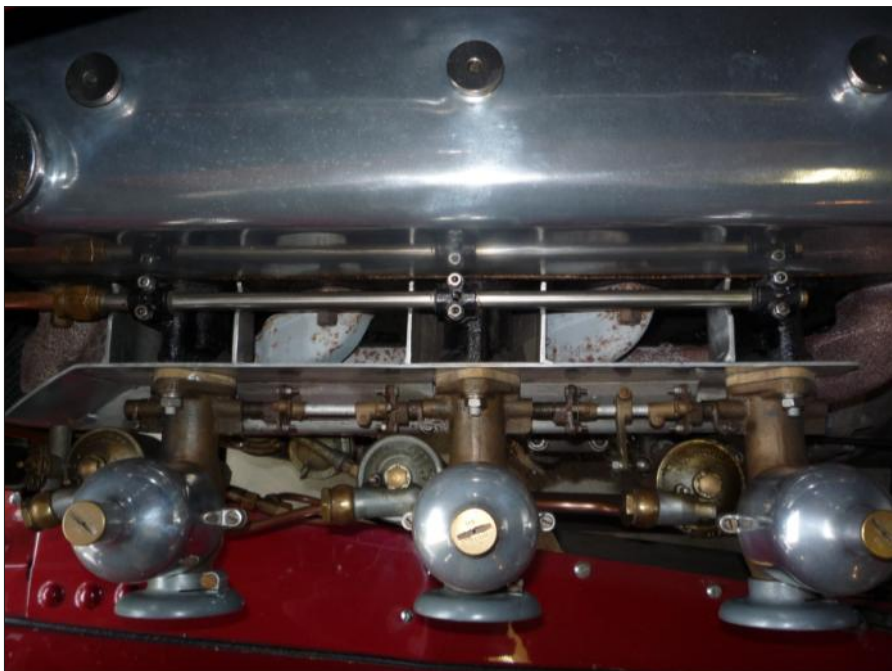
A close-up of the inlet manifold heat shield. It is made up from 3mm alloy and carefully surrounds each of the three inlet tracts separating them entirely from the adjacent exhaust outlets to give maximum heat shielding. Together with clean coolant jackets and the correct specification radiator, there are no problems even idling in traffic lines for an hour or more in 30 degrees C ambient temperatures. An electric cooling fan is fitted and ensures a good air-flow over the intake system in hot conditions.

A sophisticated alloy heat shield will improve vapor problems from the hot exhaust manifolds below the carburetors. The first thing is to cut the three inlet stubs away from the exhaust manifold. These combined manifolds were an old idea known as a 'hot-spot' to aid fuel vaporization in the pre-war days of 70 octane fuel in winter conditions. It's totally unnecessary these days with modern fuels and can be a nuisance in hot weather.

Grind away enough material from each inlet tract to give the maximum air gap. Be careful – the thickness can vary from casting to casting. A heat shield may be made up from fairly thick alloy dividing most of the inlet stubs from the exhausts in a neat, effective way.

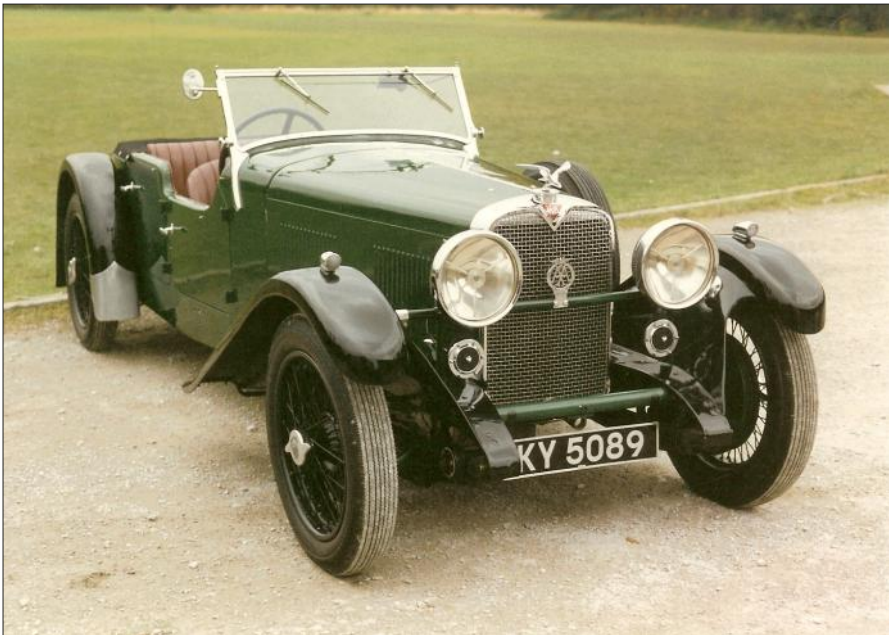
One of the 26 pre-production cars with the flat radiator. Chassis 9433. KY5089. These early cars were allocated chassis numbers interspersed between 12/50's, 12/60's and Silver Eagles. Early cars were eagerly sought after as used cars in 1932 and many were updated with the later, fashionable 'V' radiator. This was expensive work as not only was the scuttle narrower on these early cars, but also the front of the bonnet....

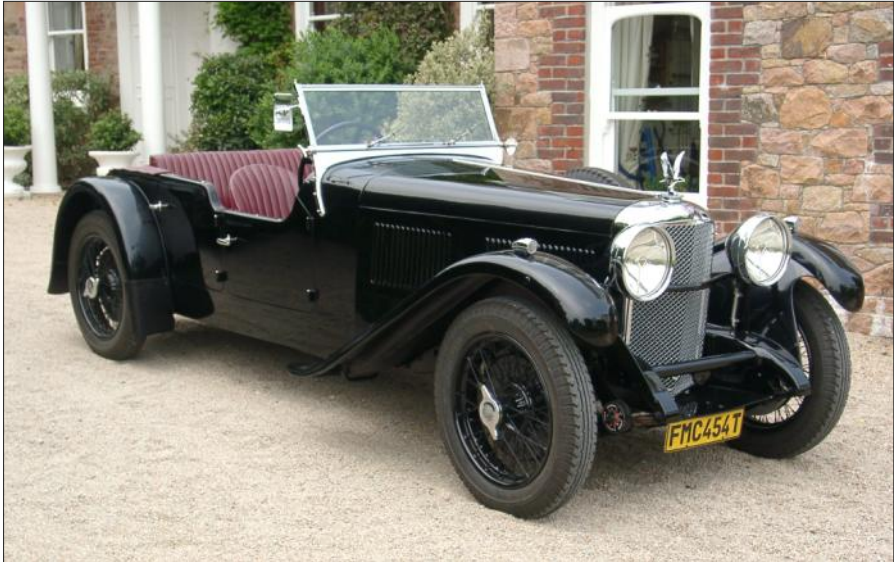
Chassis 9896, a 'standard' 1932 Cross & Ellis Sports formerly registered as OJ1556. This car was one of a pair bought new by the brothers Stone who kept them for years, appearing at AOC events in the 1960's. The brothers had consecutive chassis and Registration Numbers! It is believed this car is in South Africa.

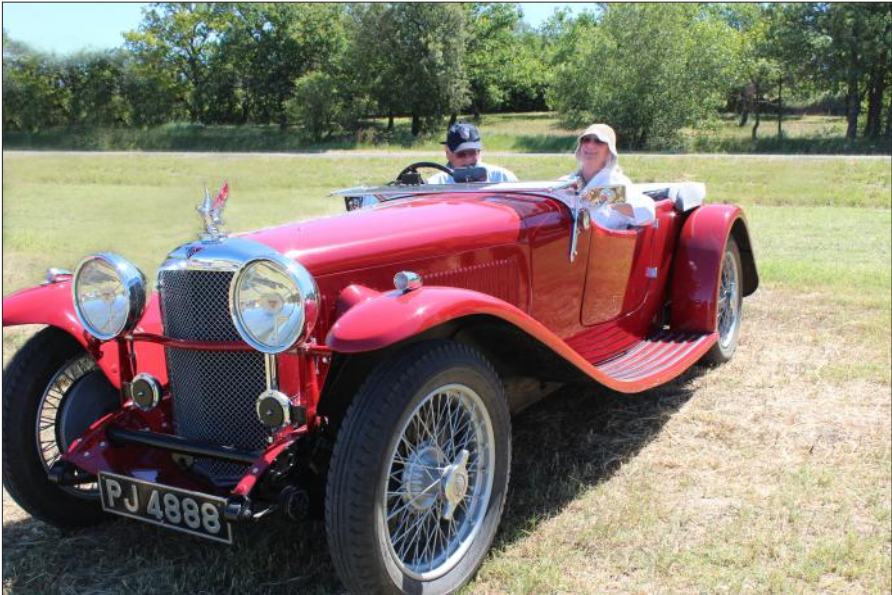
The Author, with Clarissa, his SA20 chassis 9802 and Patricia his other wife laughing uproariously at his failed attempt get into first gear silently in front of an audience. This is the first production Vanden Plas sports, an early 1932 car with the 'small' doors.

1932 Vanden Plas open sports models had rather small doors with cute angled shut lines set high in the vintage style with the lower edge of the body running continuously front to rear below the doors. The boot was accessible from behind the rear seat with no external access. 1933 Model Year bodies had deeper doors 'cut-through' to the running boards with the body sill behind the closed door and the boot was accessible through an ingenious exterior boot lid equipped with a sliding section of boot floor to close the gap between lid and boot floor when carrying a trunk on the lid in the open position. Saloons for both years had less obvious changes with the angle of door shut lines becoming less vertical and ending with softer curves at the front lower edge. Vanden Plas coupes were available either as drop-head or fixed head with similar lines and style modifications as the saloon for the two model years. Cross & Ellis coachwork is constructed with steel panels over an ash frame and Vanden Plas were mostly alloy over ash. After 80 years of use most bodies will need an overhaul and this usually means the panels must be removed to access the frame to make repairs or replacements. I found that most wood frames have a re-useable content and this saves money during overhaul as well as preserving originality as far as possible. The big skill for a body repairer is to fabricate wood repair sections that allow the original panels

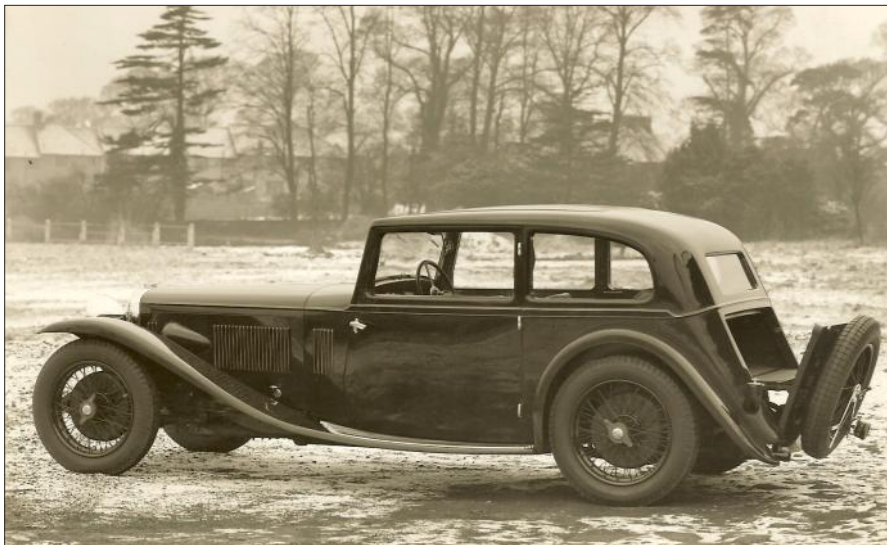
A Vanden Plas saloon photographed when new at the Vanden Plas Works before dispatch, probably a 1933 model. Note the painted 'slave' wheel transit nuts, removed before dispatch. These were popularly known as 'Straight-backed' saloons and Follett sold 28 of them. With the boot lid open, the extending boot floor to carry a trunk may be ascertained.

The 1932 body is stronger as there is no boot lid; the 1933 style has a boot lid with the wheel bolted through in the same way but the whole relies on the integrity of the hinge to frame structure so this style needs very strong repair. Cross & Ellis bodies have the spare wheel side-mounted directly on the chassis so have less worries in this area; their panels are steel giving better torsional strength and the boot lid is relatively small and non-structural, so gives less trouble. Don't be tempted to weld the lower back panel into place; it's intended to be removable as the fuel tank has to pass out that way when required....

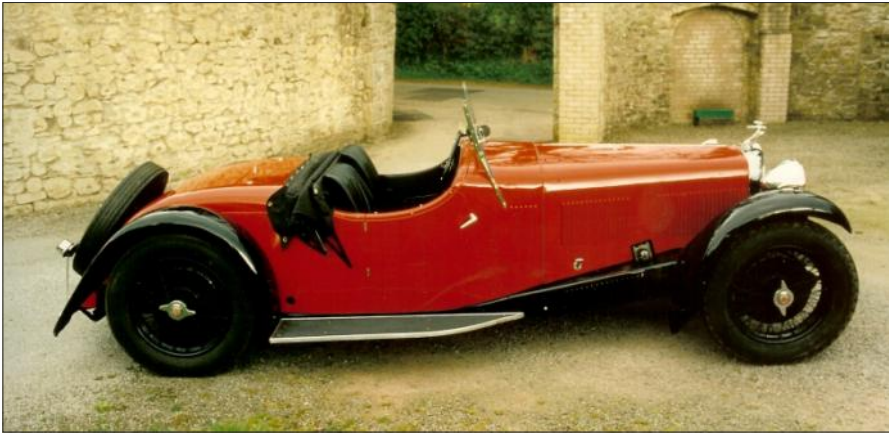
Another coachwork variation; the author's 1933 Vanden Plas two seater. Chassis 10158, AGU241. The first owner, Lester Matthews, a minor Hollywood star used the car at Brooklands and later took it to California and used in it some early horror movies, the most prominent appearance of the car being in Universal's 1935 production of 'Dracula's Daughter'. This Alvis was one of a team of three two seater SA's sponsored by Charles Follett supposedly to storm the Alpine Rally. Originally named 'Wanderer II' it had been re-christened with 'Annie' by the time she came to me.
